**FEASIBILITY STUDY OF  
INTEGRATING THE NEW DEVELOPMENT  
WITH THE EXISTING BUILDING**

**48 ABELL STREET, TORONTO**

**Client:** Verdiroc Project Management Inc.

**Date:** June 19, 2006

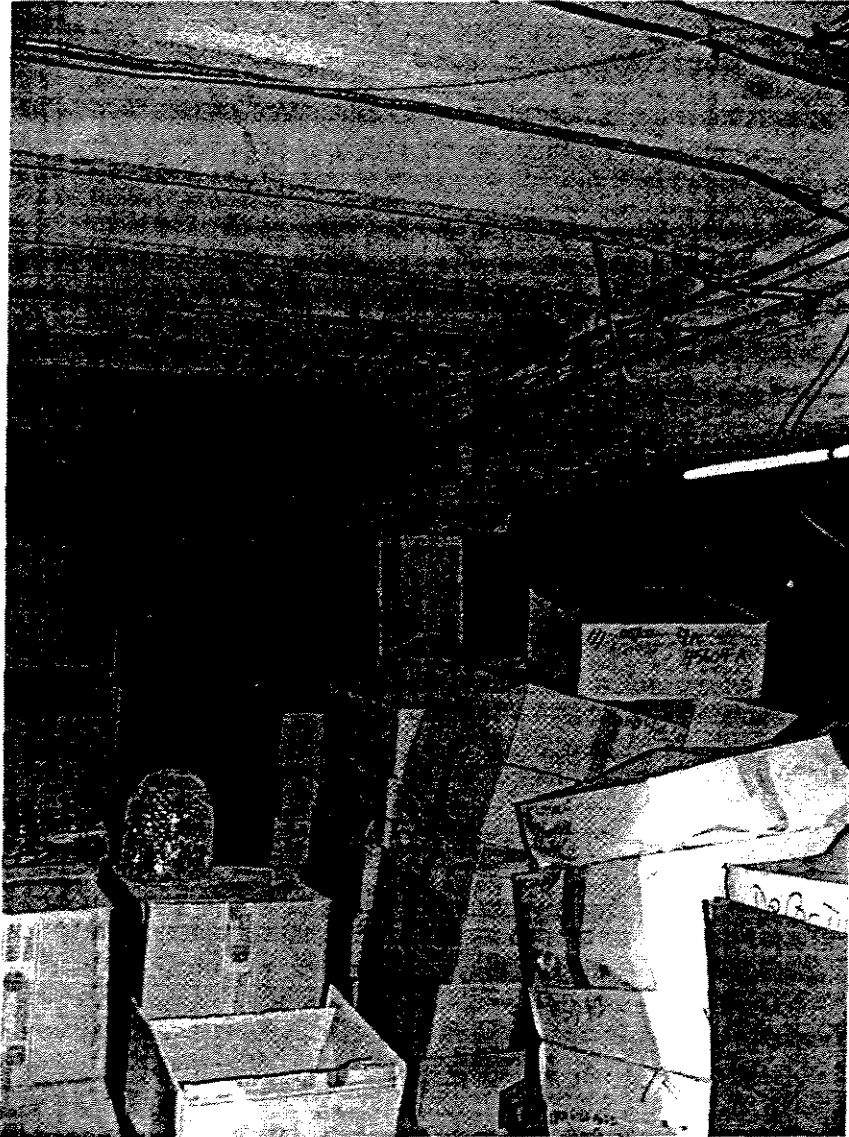
The typical construction is heavy post and beam timber construction. Wood joists span from beam to beam (figure 1). The type of floor deck was not determined at the time of the visit. Exterior walls are load bearing clay brick masonry (figure 2). The exterior walls are tied using what appears to be a cast iron tie-rod construction that ties the timber floor structure to the exterior walls terminating at round plates on the facades (figure 3). In some cases, the exterior plates do not appear to have proper bearing (figure 4). It is not clear if these iron rods and plates were part of the original (c.1887) design and construction, or if they were installed later in order to remedy bowing of the exterior masonry walls away from the floor structure.

PHOTO 1: TYPICAL BASEMENT CONSTRUCTION

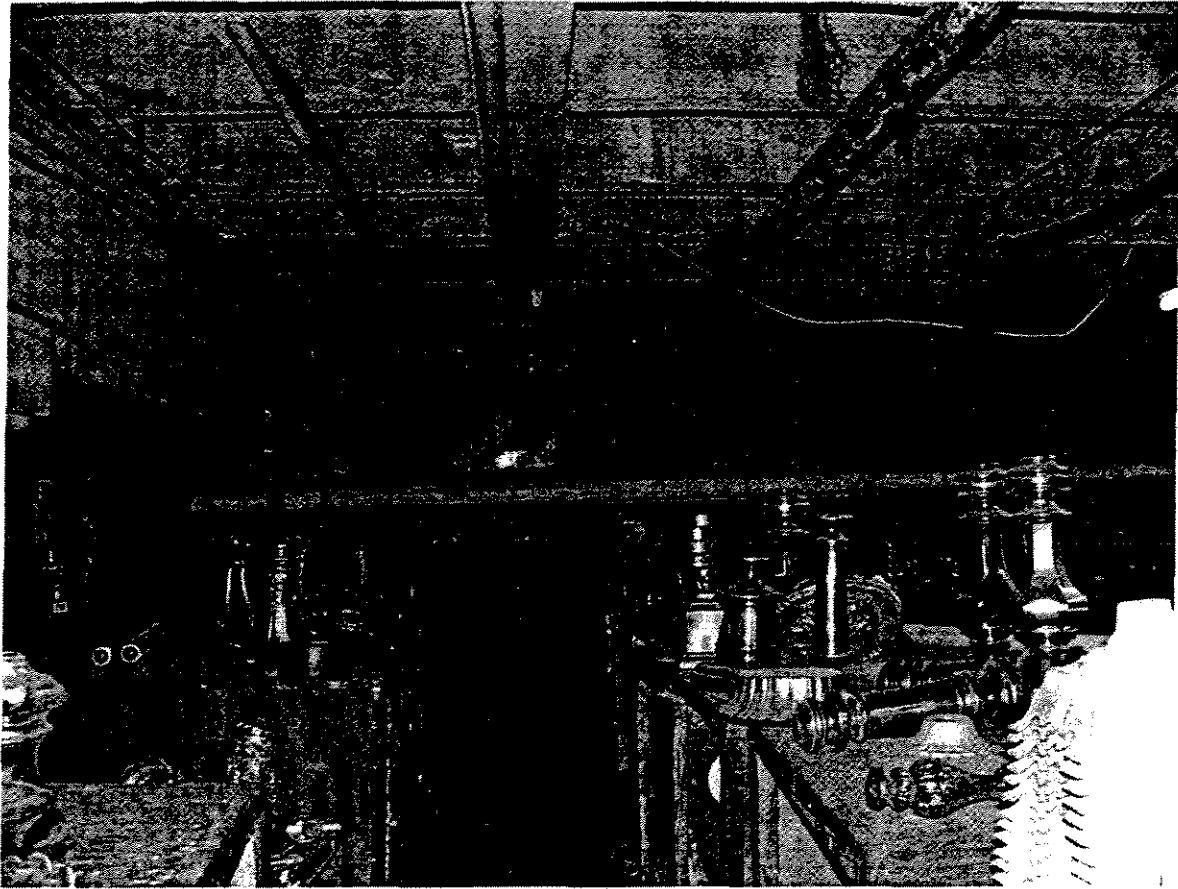
PHOTO 2: TYPICAL EXTERIOR BASEMENT WALL

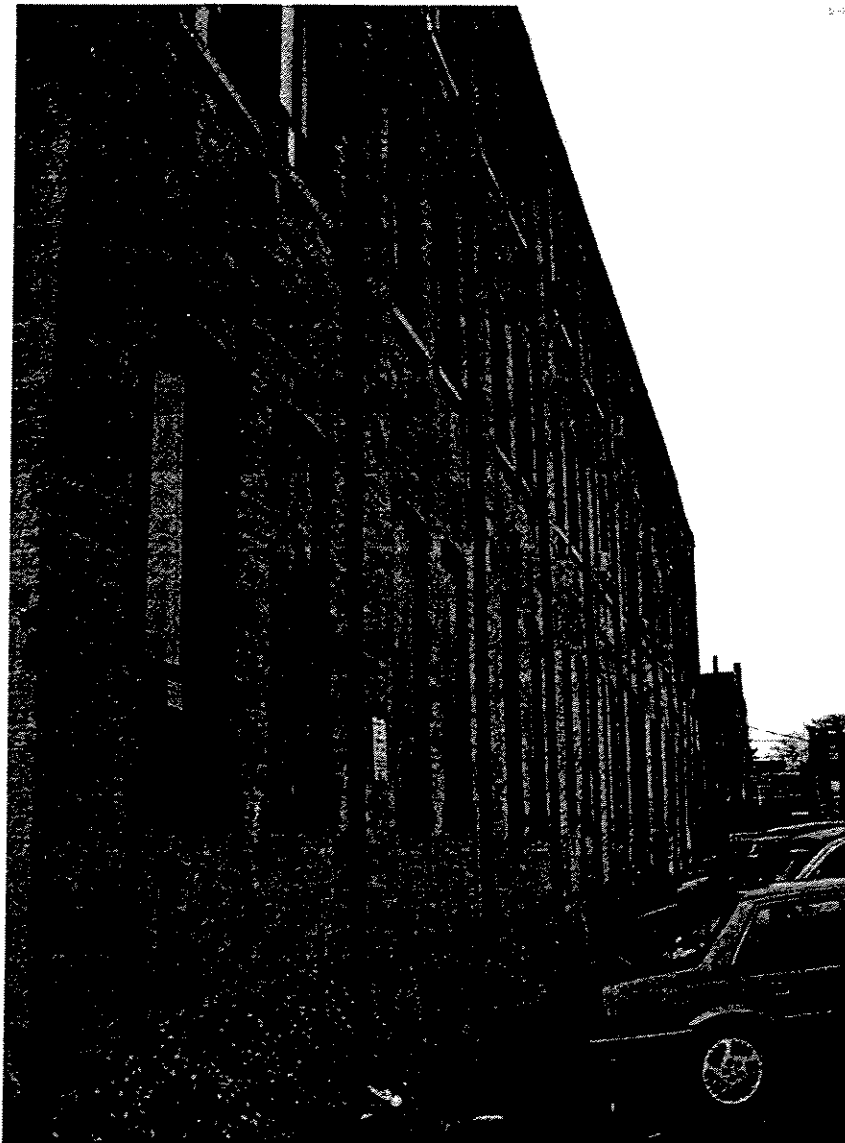
PHOTO 3: EAST ELEVATION (TIE RODS)

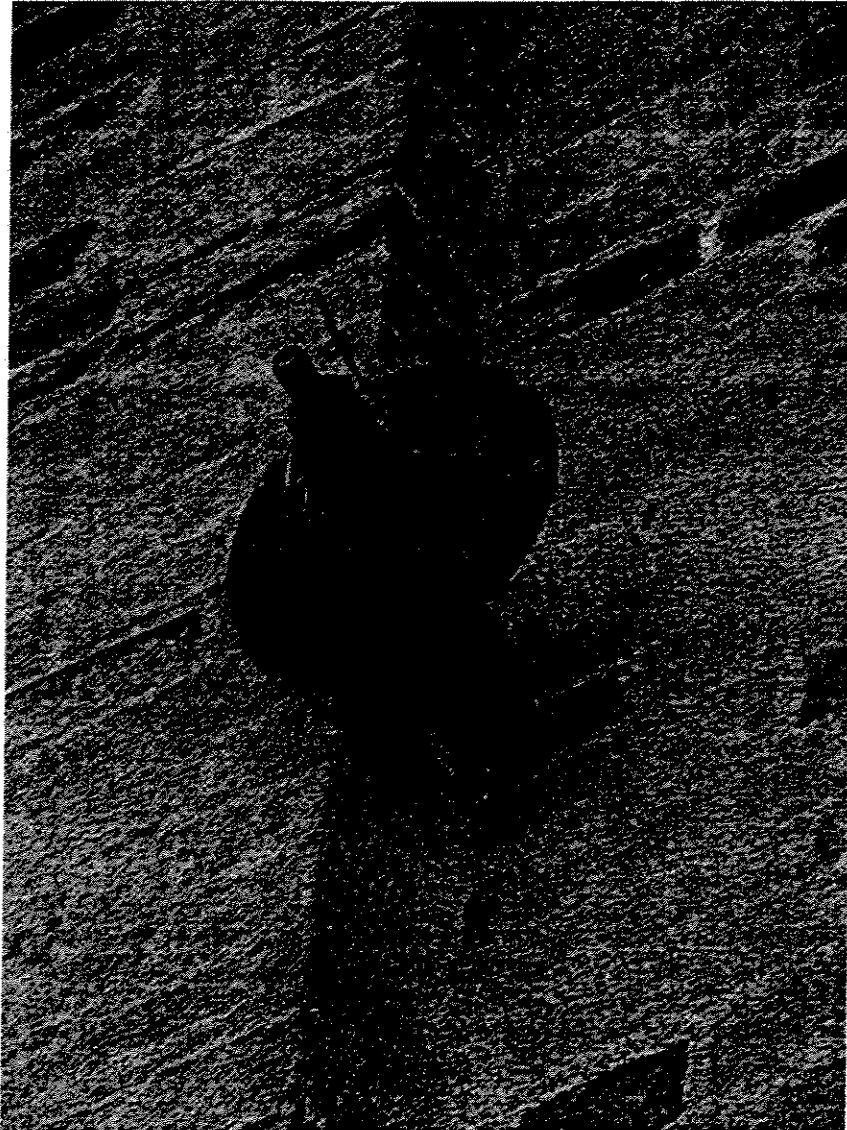
PHOTO 4: SOUTH EAST CORNER TIE ROD

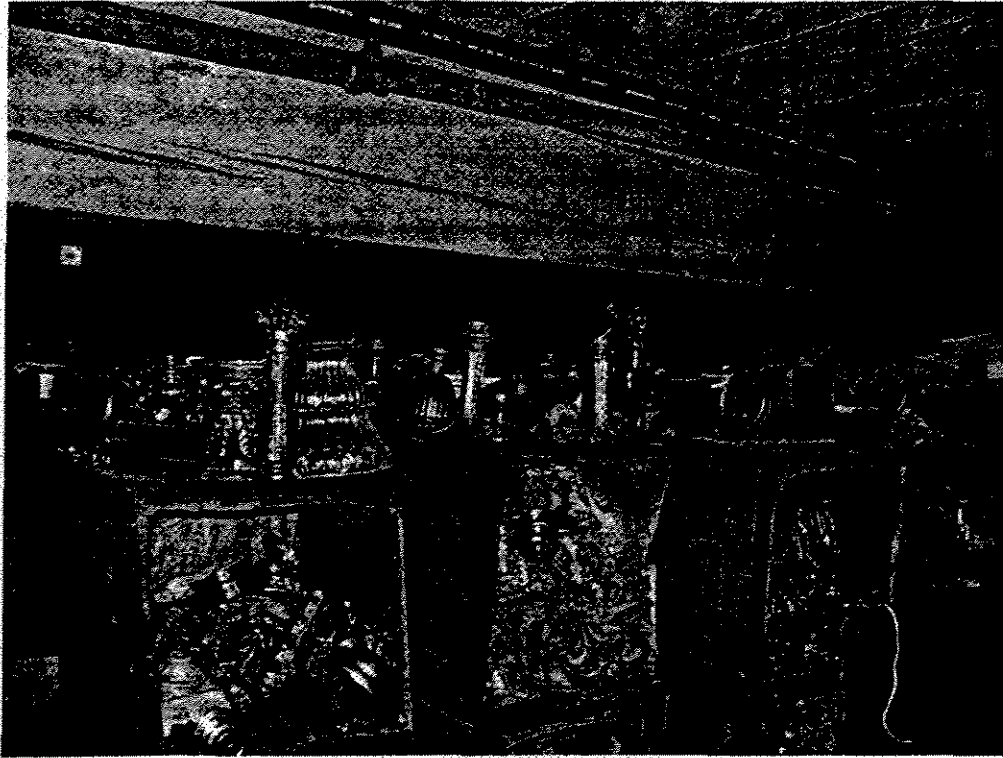
Generally, the condition of the structure varies as would be expected for the age of the structure. Several structural deficiencies were noted and will be itemized in the following section. For example, we noted checking (minor splitting due to drying shrinkage) of the heavy timber beams (figure 6) and twisting in the south-east corner of the basement (figure 7) and at the roof of the east wing. The beams that had twisted had been packed previously for bearing. Some areas of the roof had visible signs of leaks through the interior finishes, but the condition of the roof structure at these locations was not visible. The roof of the west wing consisted of an indeterminate wood deck and steel beams (figure 8). Cracking in the brick was noted along the south elevation adjacent to an overhead door (figure 9). It was also noted that there may have been a fire along the south east elevation (figure 10). Further investigation is required as to the impact the fire may have had to the structure. These deficiencies should be addressed as part of regular maintenance.

One location of concern requiring immediate action was in the basement. An interior wood column of the east wing had been removed (reason unknown) and replaced with a shoring post (figure 6). This post likely supports columns that support the additional floors above. This type of post is usually only considered as a temporary measure for unoccupied spaces. We are unsure as to how long this post has been in place. However, we recommend that the owner retain an engineer to investigate the adequacy of this post further to ensure that it meets the code requirements. This is required immediately regardless of the direction of the project to ensure the structural integrity of the building.

PHOTO 6: CHECKING AND "SHORING" POST

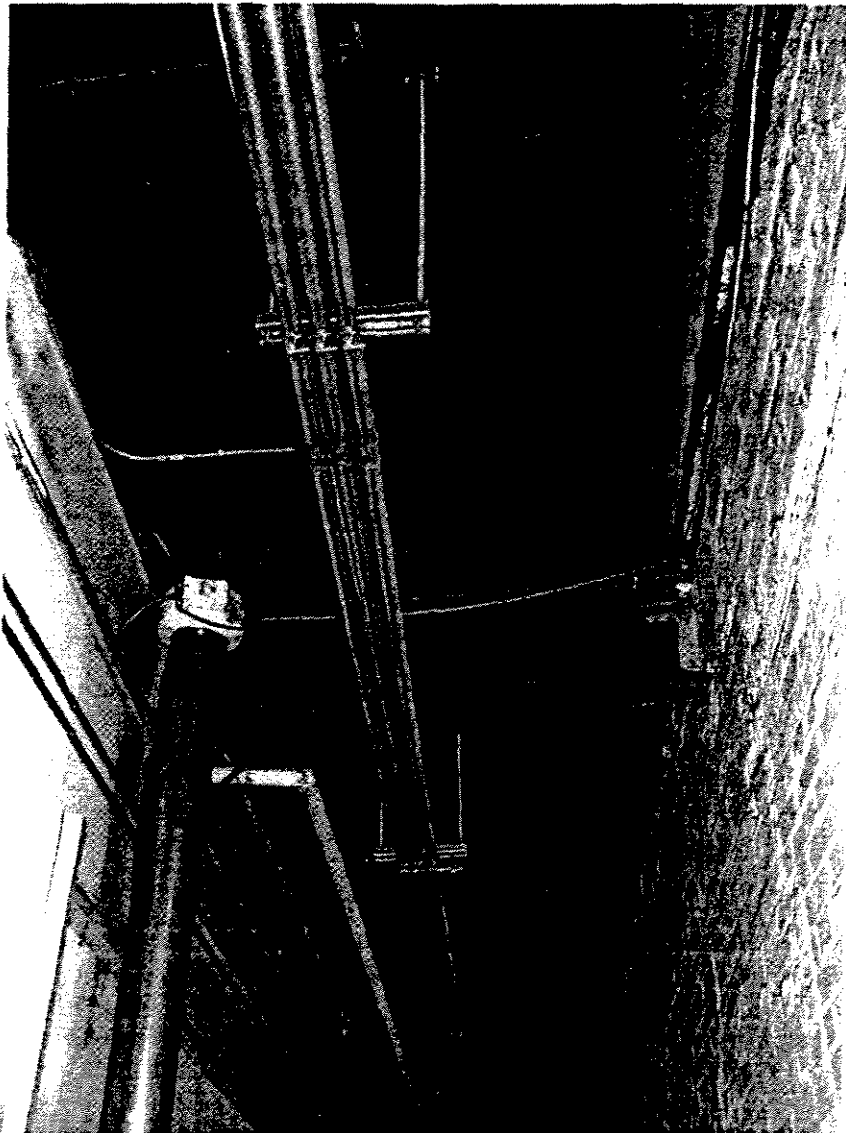
PHOTO 8: TYPICAL WEST WING ROOF FRAMING

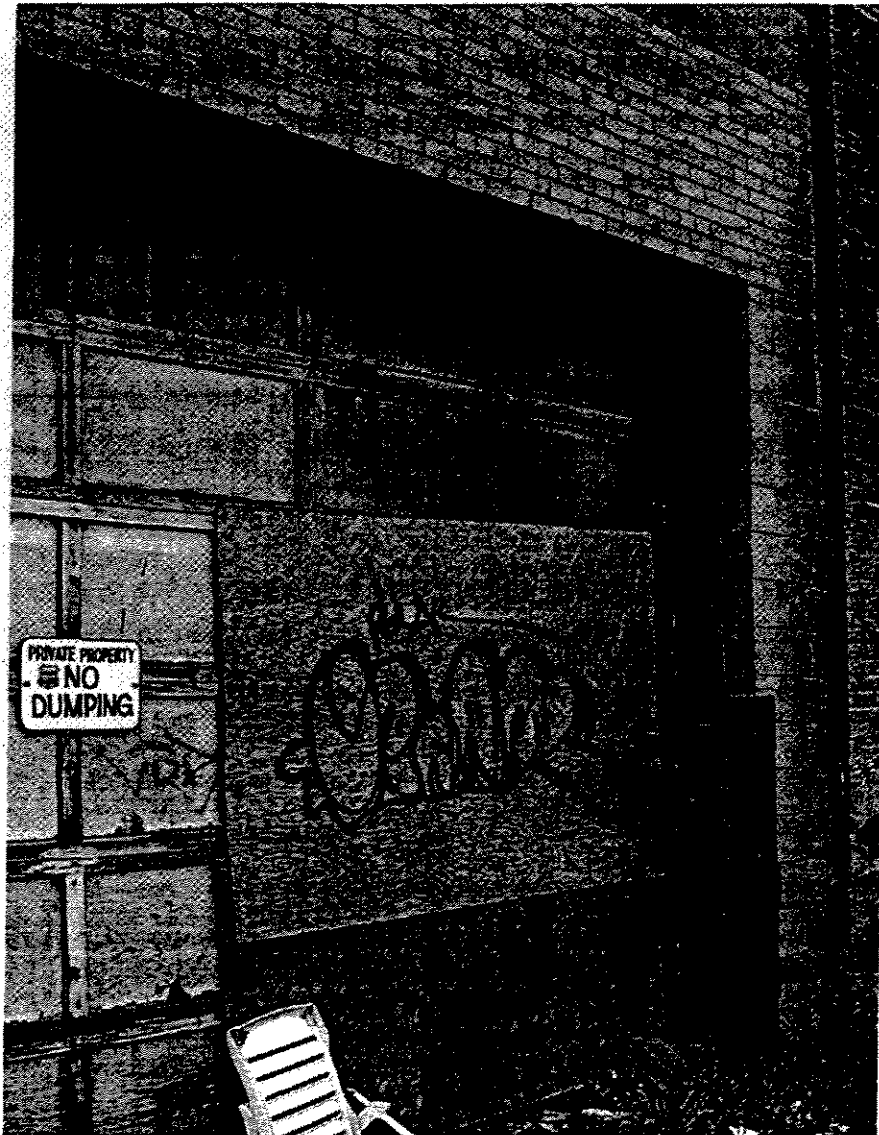
PHOTO 10: FIRE DAMAGE

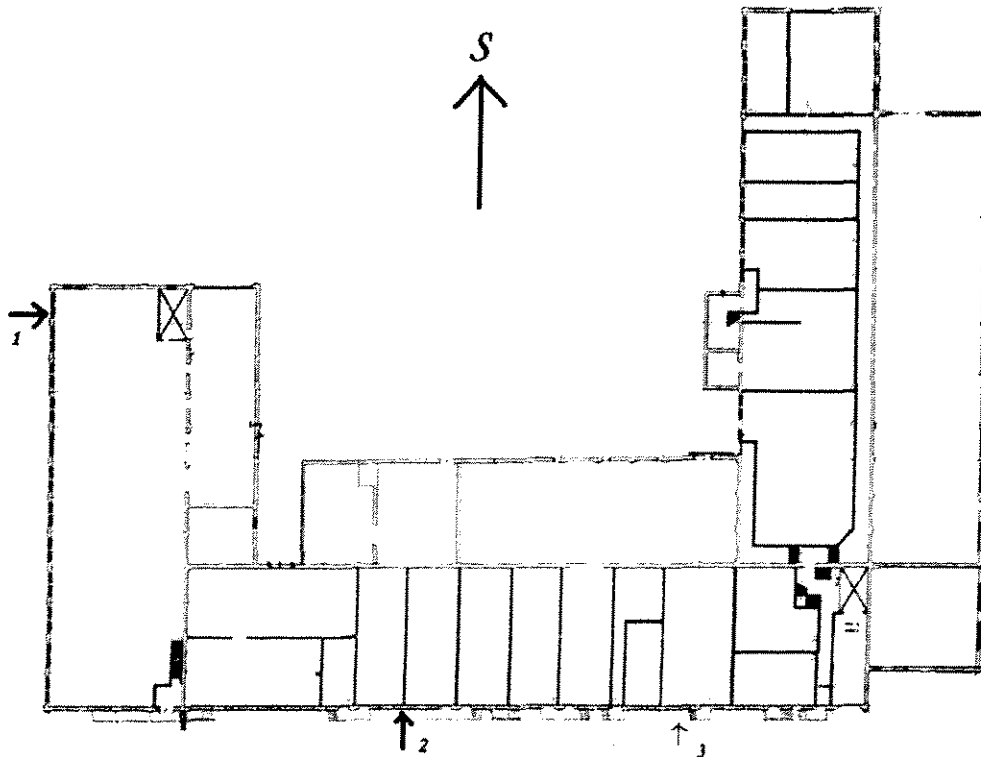
PHOTO 12: ILLUSTRATION PROVIDED BY AREA RECORDING THE SAMPLING OF THE BRICKS FOR TESTING.
